AUSTRATUS ALUMINIUM BATTEN SYSTEM

TESTING REPORT AS ISO 9705:2003

IGNL-5001-06R I01R00

Tested: 28.01.2021
Issued: 01.03.2021

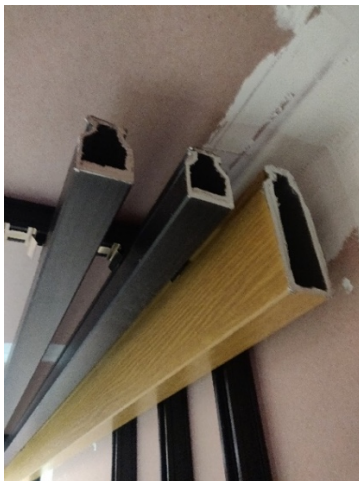
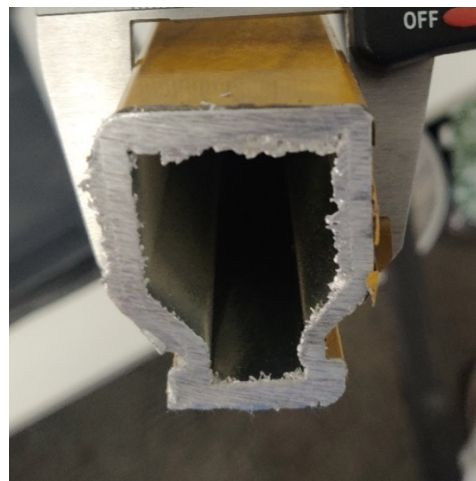
FIGURE 1:

The tested system included a ceiling and wall specimen with the installation of the Austratus aluminium batten system. As described by the sponsor, the walls and ceiling were formed by four different types of battens including sizes of 30mm×40mm, 30mm×60mm, 30mm×90mm and 90mm×22mm aluminium battens with 30mm stainless steel spring clips into aluminium TCR rail to walls and suspended from stud ceiling. The battens were installed with varying spacings. A polyester insulation was installed behind the battens. The insulation was a nominal 18mm thickness and 600mm width.

ALUMINIUM BATTEN

Black insulation material was applied to the ceiling in between TCR rails behind the aluminium battens. The battens that applied on the ceiling and three walls were 30mm×40mm black and yellow aluminium battens. Different types of battens were applied to the corners between the ceiling and three walls. A polyester insulation was installed behind the battens. The insulation was a nominal 18mm thickness and 600mm width.

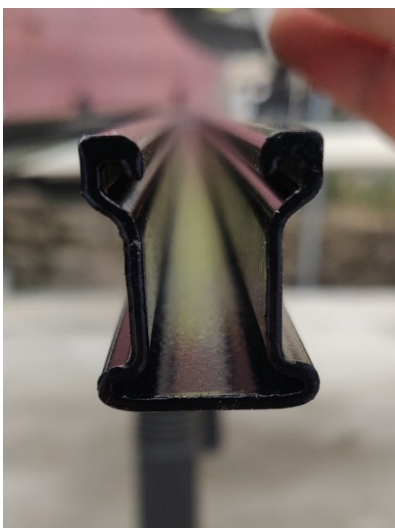
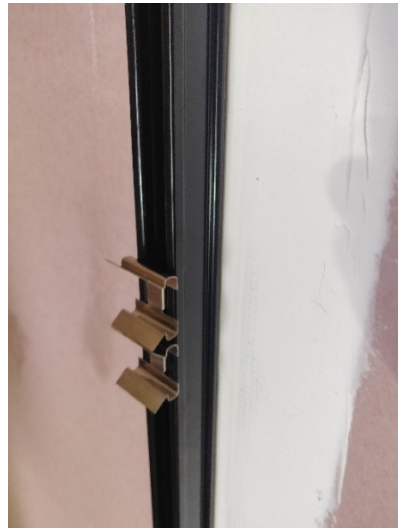
FIGURE 2:

SPECIMEN RAILS

The tested system included a ceiling and wall specimen with the installation of the Austratus aluminium batten system. As described by the sponsor, the walls and ceiling were formed by four different types of battens including sizes of 30mm×40mm, 30mm×60mm, 30mm×90mm and 90mm×22mm aluminium battens with 30mm stainless steel spring clips into aluminium TCR rail to walls and suspended from stud ceiling. The battens were installed with varying spacings.

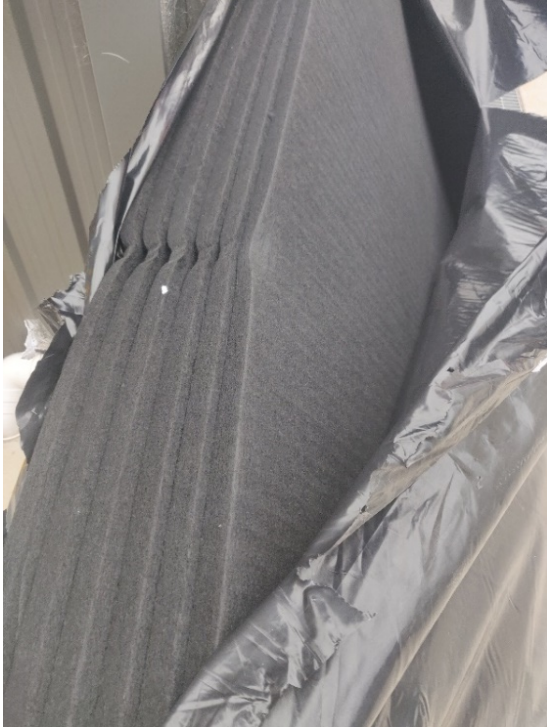
FIGURE 3:
INSULATION APPLIED AT THE CEILING

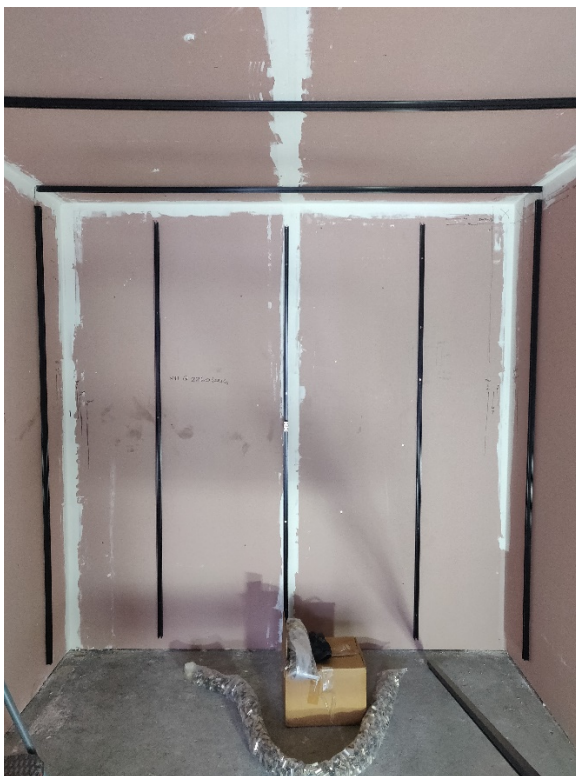
FIGURE 4:

SPECIMEN RAILS INSTALLATION

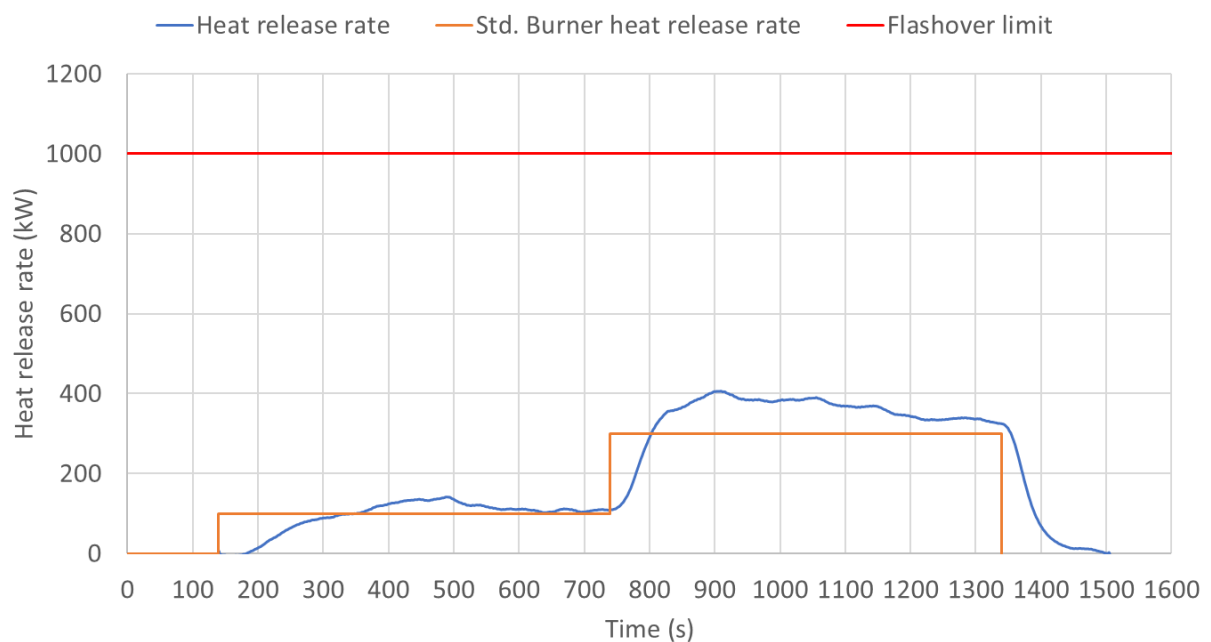
FIGURE 6:

The heat release rate during the test is shown in the figure below. The heat release stays below the flashover limit of 1MW during the whole test.

HEAT RELEASE RATE MEASUREMENTS

The National Construction Code of Australia (NCC) and AS 5637.1:2015 detail the criteria of materials by Group Number, which indicates the amount of time taken for a material being tested to reach flashover under AS ISO 9705:2003 R2016 test conditions. AS 5637.1:2015 define flashover to be a heat release rate of 1000kW.

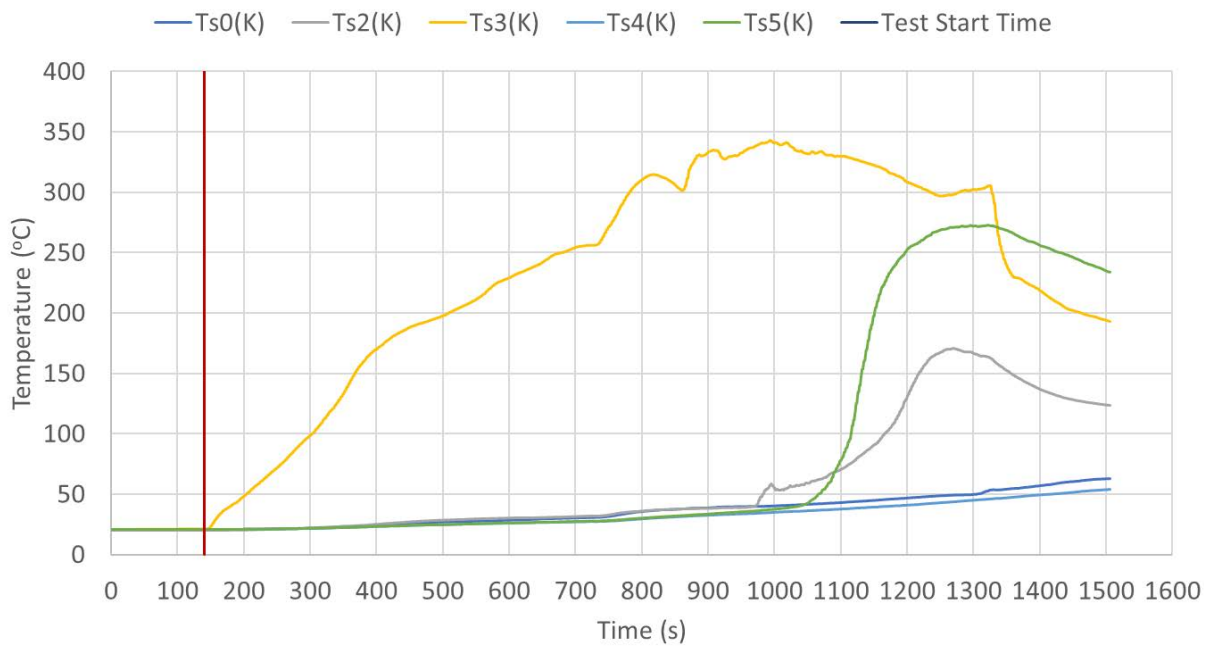
FIGURE 8:

Based on the nature and intent of the tests, the thermal conditions within the room as measured by the thermocouples. The temperatures in the room for the two trees are detailed below. The test burn included a measurement for twenty minutes with the sandbox burner increased to 100kW output for 10 minutes and then increased to 300kW for an additional 10 minutes.

The thermocouple detail shows the impact of increasing the flame size. The figures below detail the thermocouple tree.

THERMOCOUPLE MEASUREMENTS – THERMOCOUPLE TREE

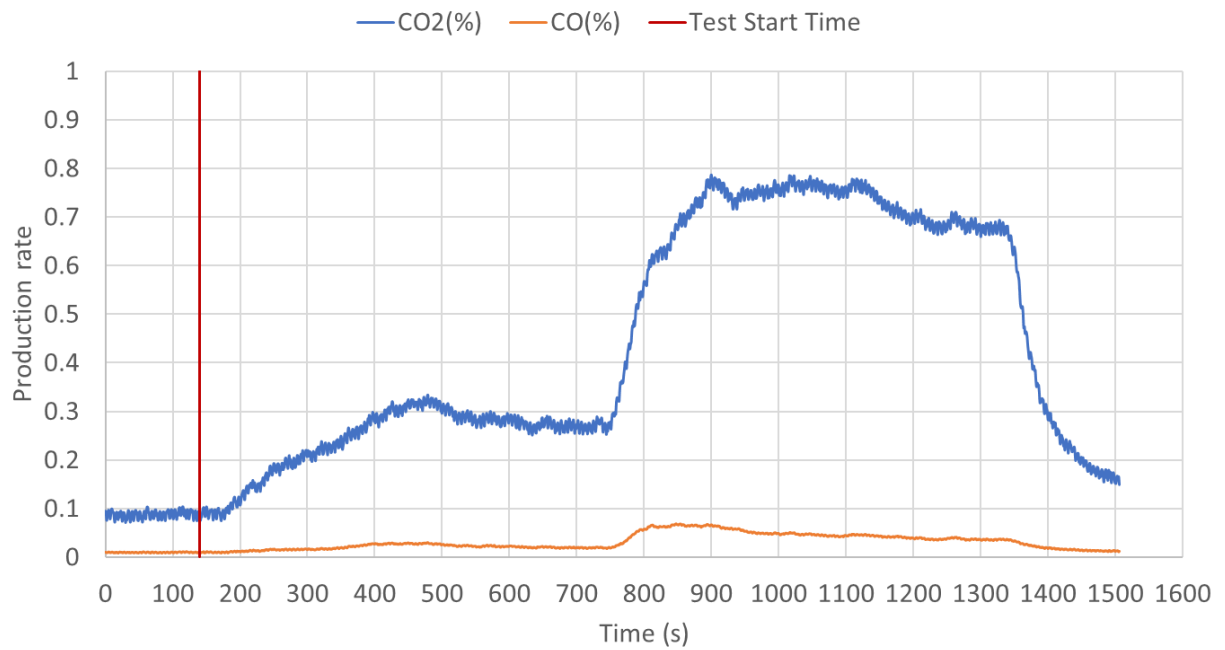
FIGURE 10:

An exhaust sampling probe sampled the combustion products which were analysed by a Servomex Servopro 4000 series analyser. Oxygen concentration during the test was determined by the paramagnetic oxygen analyser, whilst the carbon monoxide and carbon dioxide concentrations were determined within the Servopro 4000 analyser.

CARBON DIOXIDE AND CARBON MONOXIDE PRODUCTION

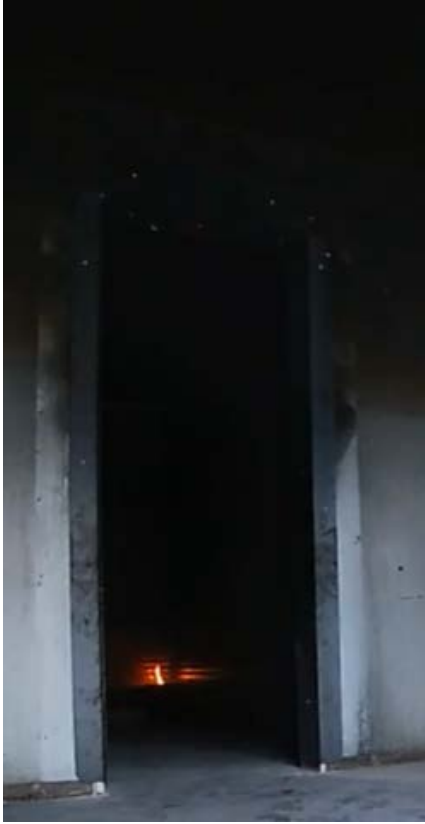
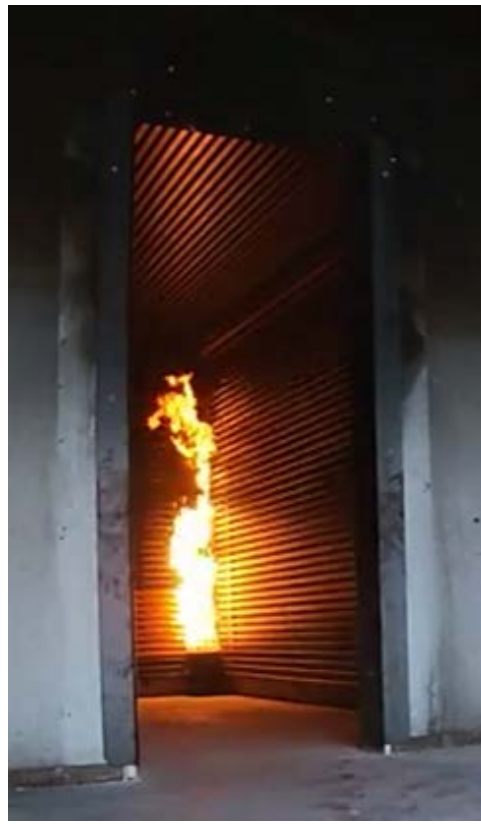
FIGURE 13:

START OF THE TEST – 0KW

2:20 INTO THE TEST – 100KW

0:00	Test start.
2:20	The heat release rate of burner increased into 100kW.
3:35	Charring was observed on slats 450mm above the burner.
4:15	Light visible smoke layer was formed
5:00	Molten debris was observed on slats.
5:38	Molten debris was observed on floor surround the burner.
5:50	Smoke started to come out of the doorway.
6:00	The paint surface of batten behind the burner was burning.
6:55	The smoke became heavier and made the ceiling became invisible.
12:20	The heat release rate of burner increased into 300kW.
12:35	Smoke became lighter and the ceiling started to be visible. Flaming debris from ceiling was observed.
14:00	Sustained flaming was observed on ceiling.
16:40	No more flames were observed on ceiling.
24:00	Test stopped.

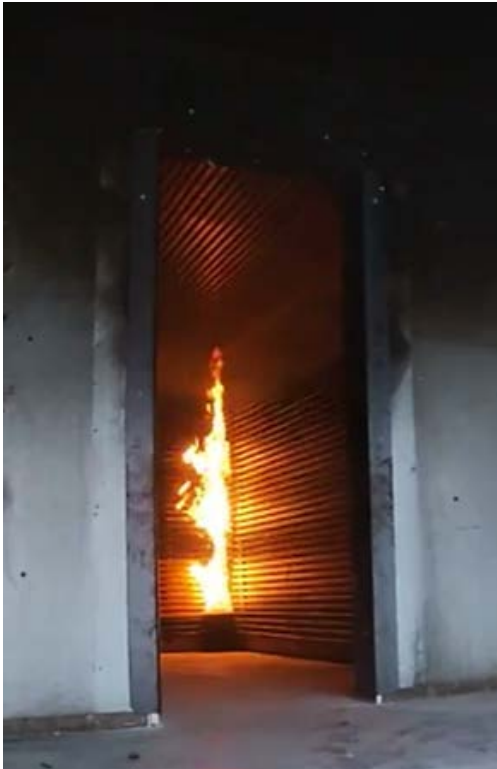
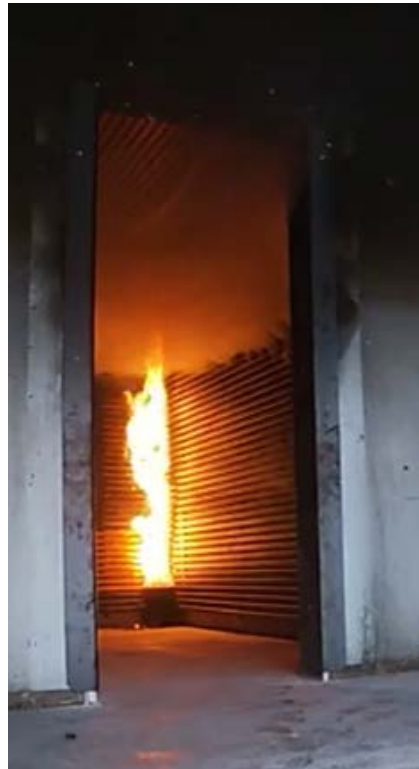
FIGURE 14:

4:38 INTO THE TEST – LIGHT VISIBLE SMOKE LAYER

5:38 INTO THE TEST – MOLTEN DEBRIS ON THE GROUND

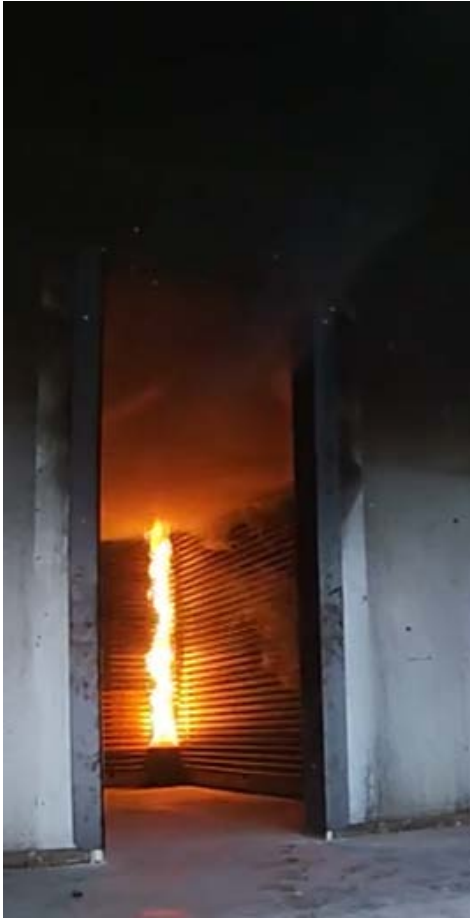
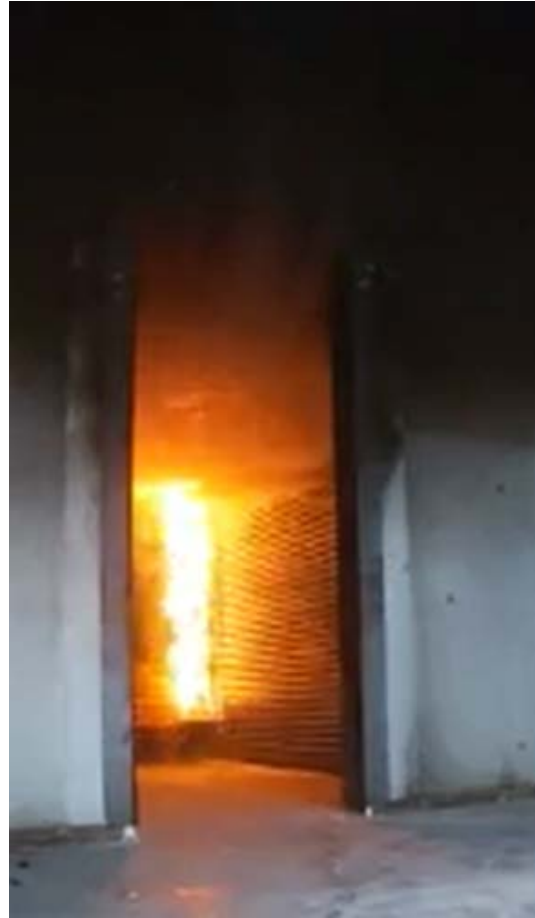
FIGURE 15:

5:50 INTO THE TEST – SMOKE CAME OUT OF THE DOOR

12:20 INTO THE TEST – 300KW

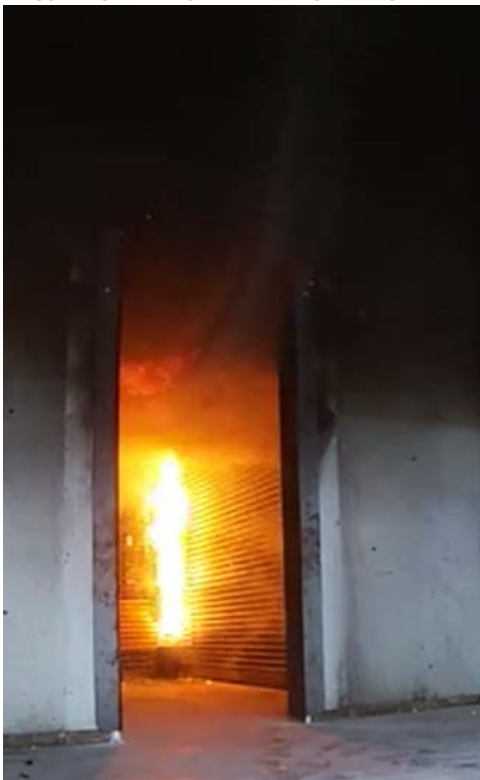
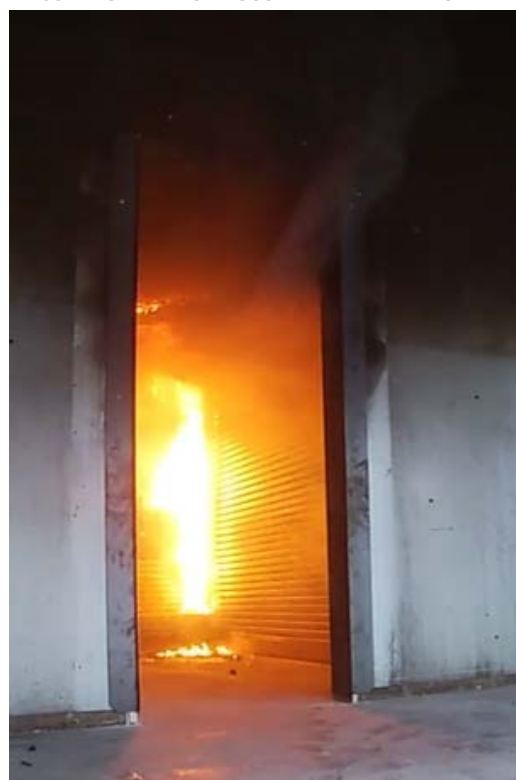
FIGURE 16:

12:35 INTO THE TEST – FLAMING DEBRIS

14:00 INTO THE TEST – SUSTAINABLE FLAMES AT THE CEILING

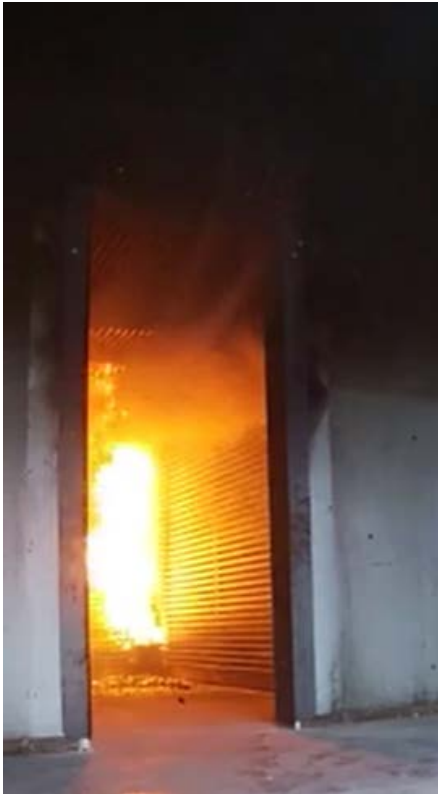
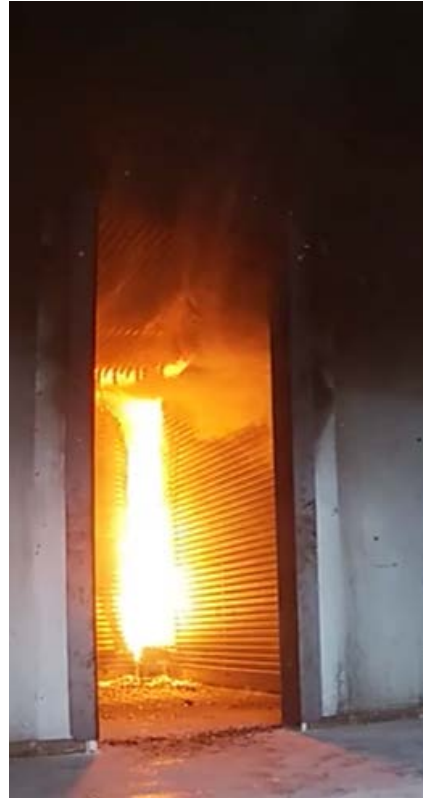
FIGURE 17:

16:40 INTO THE TEST – NO FLAMES AT THE CEILING

24:00 INTO THE TEST – BEFORE THE STOP OF THE TEST

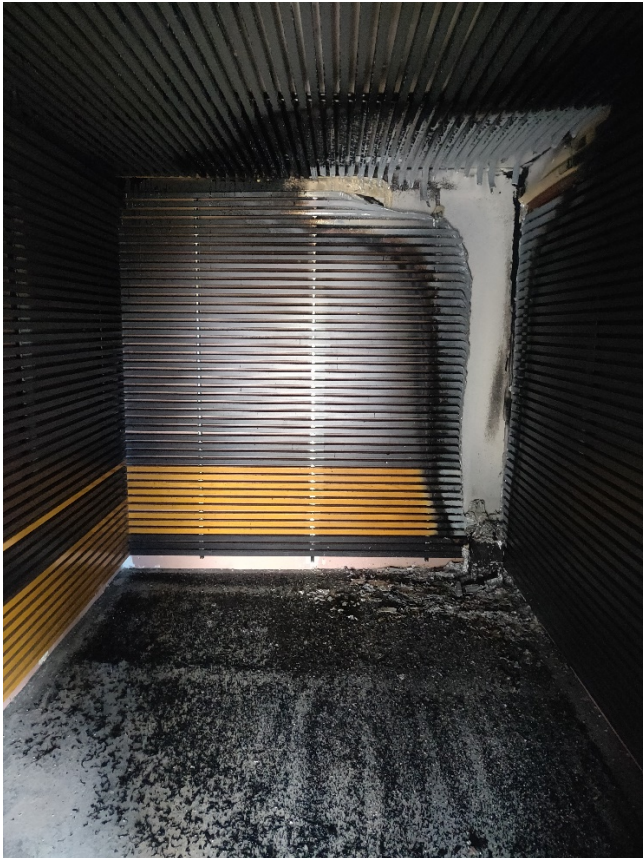
FIGURE 18:

ROOM POST THE TEST – OVERVIEW
