Salt Spray Test Report.

Test Report # 5482.11

Part Description : Al Siding with powder coated decorative finish.

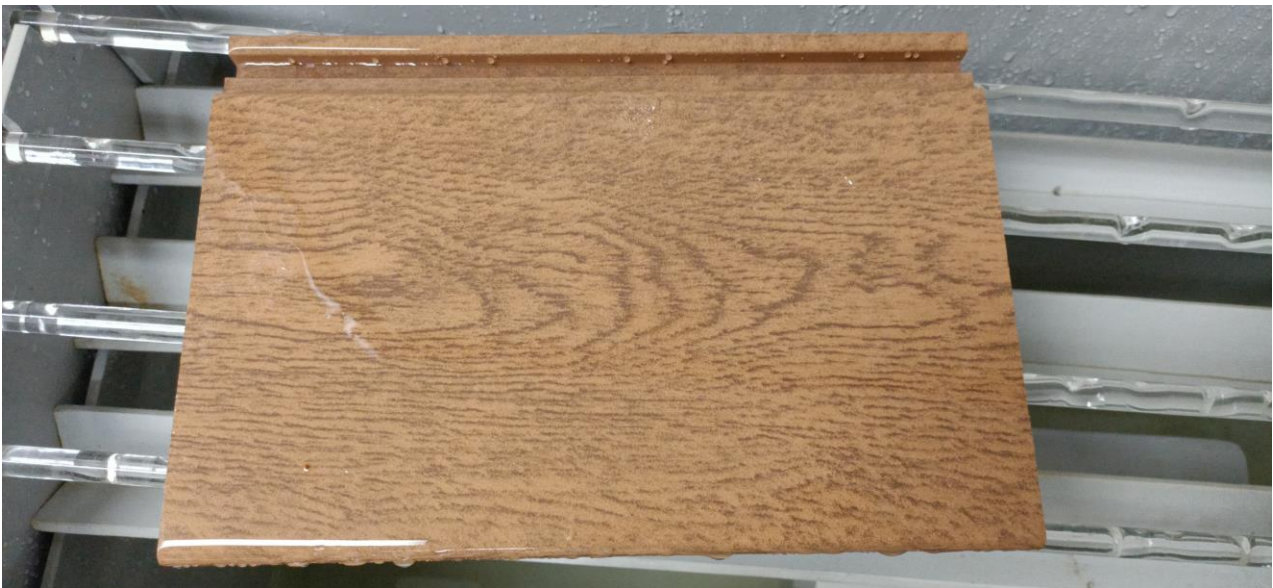
Part Identification : 2 x Samples were provided approx. 300 x 5000mm x 20mm.

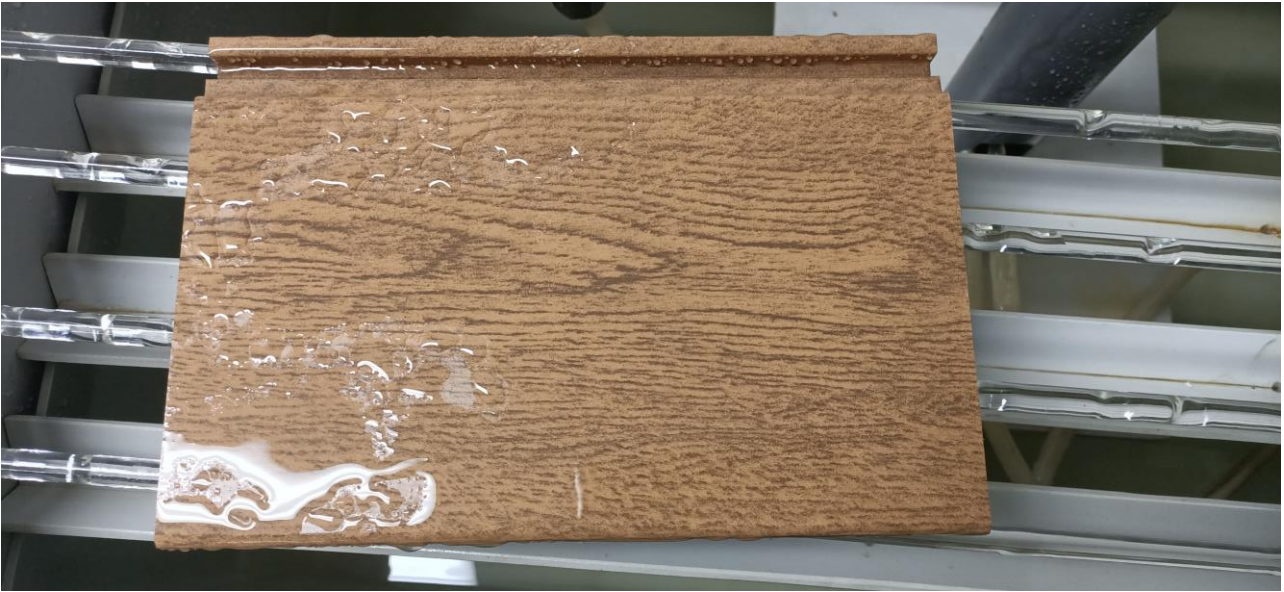
Sample Number	Marked Cut Samples with dots 1 -4
Date of test	18/10/24 – 24/10/24
Test Temp of Solution (deg C)	35 +/- 1
Solution Mixture	5% NaCl
Test Duration (hrs.)	144
Inspection at 24 hrs.	No signs of white corrosion
Inspection at 48 hrs.	No signs of white corrosion
Inspection at 72 hrs.	No signs of white corrosion.
Inspection at 96 hrs.	No signs of white corrosion
Inspection at 120 hrs.	No signs of white corrosion
Inspection at 144 hrs.	No signs of white corrosion or damage to coatings.

Result: The samples complied with the requirements.

Sample After Salt Spray Test.

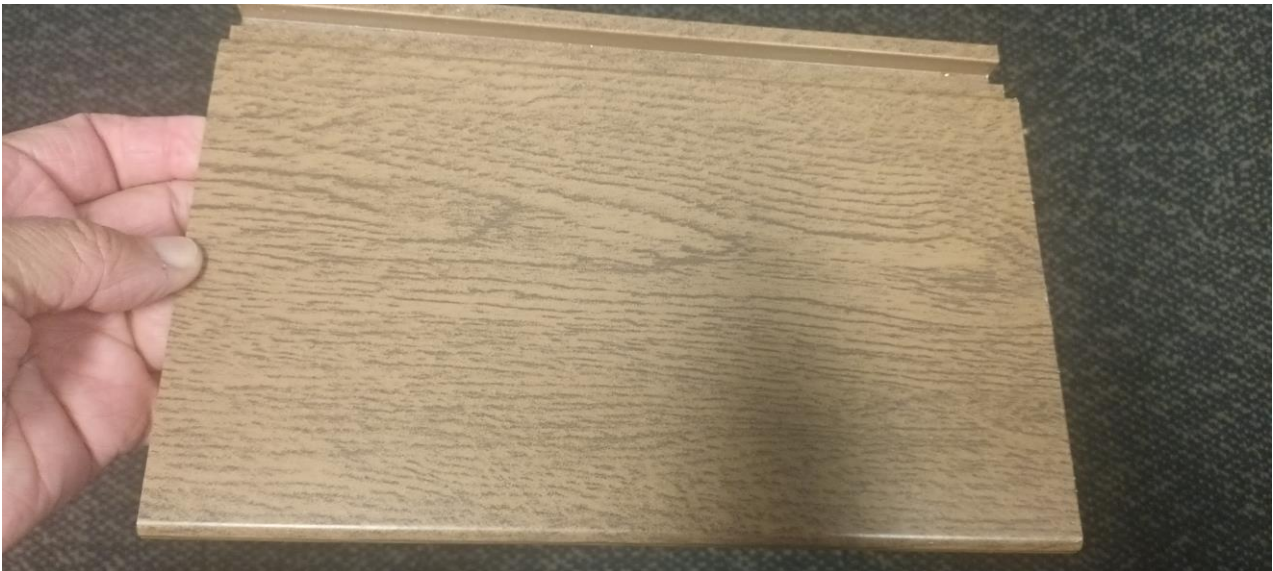
Test Item	Duration	Result
Coated Al Sample	24h	No residue from mortar was left on the sample.

Result: The samples complied with the requirements.

Sample after cleaning from mortar test.
